Service Solutions

Solving Problem Extends Pump Service Life

Problem: A gulf coast refinery was experiencing excessive maintenance costs on a backup barrel charge pump (diffuser type). The pump is a 3x11 CB 12 Stage, Hydrocarbon Service, C-6 Metallurgy, 3560 RPM, 591 GPM, 5447 TDH, .8 Sp. Gr., 20' NPSHr, 23' NPSHa, 550-600 Deg. F, 1000 HP Motor Drive. The pump runs only short periods of time each year. Due to repeated patches and the inherent design of the original pump, the working tolerances and its reliability had exceeded all reasonable levels. The pump was the top priority of the facility for review and upgrade.

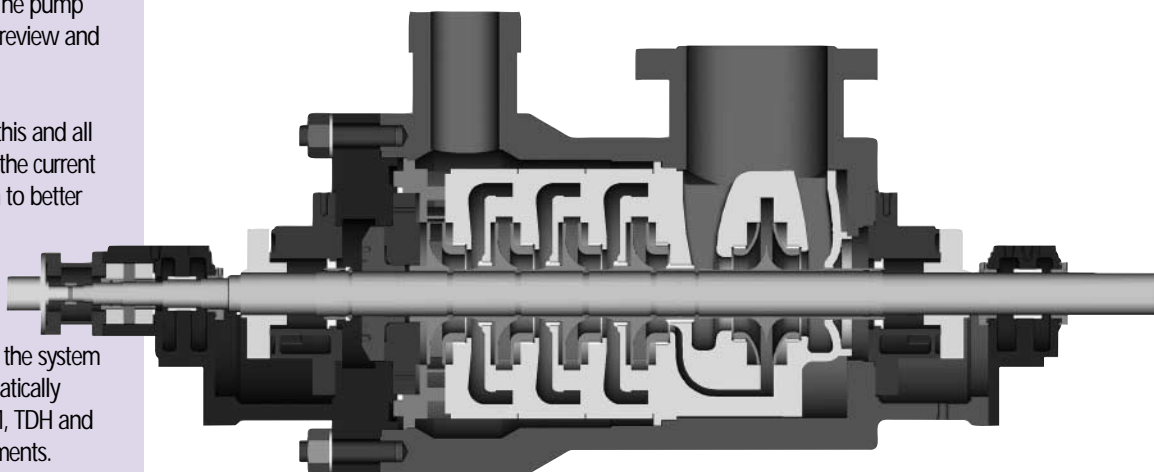
Figure 1.

As can be seen in the cutaway of the pump (Fig. 1), the rotor is a multi-stage design with impellers back to face through the length of the rotor. This requires a unique balance device with very defined dimensions. Without proper sizing the pump will thrust excessively. Thrust bearing failure could result in severe damage to rotor and diffusers. In this case the balance drum diameter had been modified over the years, which was adding to but not the main cause of the reliability issues.

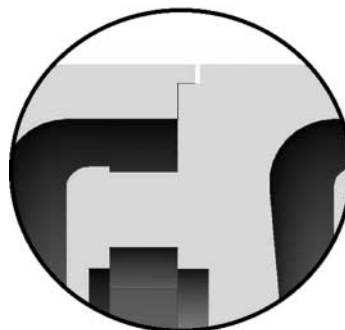
Figure 2.

After a complete inspection of the pump in our PRO Service Center, several areas of a mechanical and metallurgical concern were discovered. The pump was originally designed with a rotor that utilized shrink fit impellers with locating split rings on the shaft, which meets current design. The diffusers and barrel registers, however, were not within current design standards. The diffusers were fitted with a loose slip fit to each other, which allowed for a stack up sag (run out) in the diffuser assembly as shown in Fig. 2. This sag can easily allow wear parts to rub excessively while in operation. Current API running clearances are typically more liberal than the original design of these pumps. The registers of the barrel to covers were also found to be excessively loose due to years of use. The metallurgy for the wear parts in this pump were all standard heat treated 410 SS. Even with the recommended 10 Rc variance in the stationary and rotating parts, the short life of the parts merited a close look at a better selection for the working surfaces.

Solution: We proposed a complete weld up and re-machine of all registers between the diffusers. This would provide a tight fit, a more rigid bundle, and no stack up sag. The registers of the barrel to its covers were welded and re-machined to allow for a low clearance register fit. These register corrections allowed for a very tight pump assembly with little stack up sag. The wear parts were all replaced with new wear parts over-laid with Colmanoy #5 and #6 to give a harder, less galling surface, still with the required hardness differential. The pump has run successfully for several years now without any pump downtime. It was clearly viewed as a successful upgrade by the owners.
