Material Matters

Practical Failure Avoidance and Prevention (Analysis of a Heat Stress Damaged Slurry Pump)

Steve Morrow, Global Manager Materials Technology, ITT Industrial Products Group

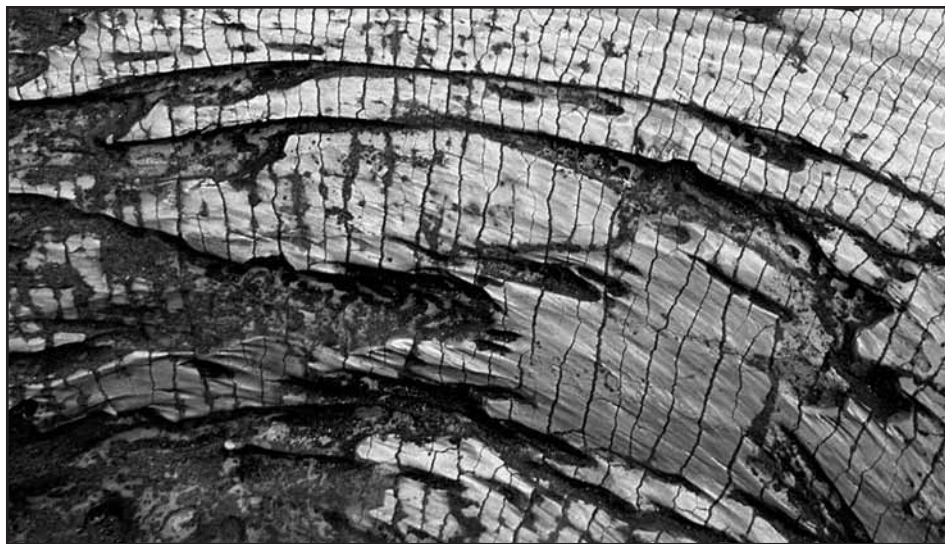
Figure 2. Close-up of extensive "Heat checking" characteristic of thermal fatigue cracking.

also accompanied by high contact stress and surface heat stress due to thermal expansion. Loss of specified clearance between the cover and impeller is believed to have occurred at some earlier point in the service operation, resulting in rubbing contact and frictional heating. It appears that the pump housing adjusting bolts may not have been properly tightened or improper impeller adjustments were made that allowed the impeller to make contact with the suction cover. At the interface between the cover and impeller surfaces damage rapidly escalated, accompanied by gross overheating and thermal stress cracking due to contact rubbing. A close-up of the worn and "heat check" thermal fatigue cracked surface is shown in Figure 2.

The source of extensive cover cracking and accelerated wear is believed to be the direct result of localized surface heating. The effects of heating not only creates thermal fatigue stress cracks, but also introduces a thermal tempering effect resulting in microstructure transformation

changes and metal softening that reduces the overall hardness and the high chromium iron wear resistance, leading to accelerated and premature wear damage.

Metallographic examination of a section taken from the worn and damaged surface revealed that the microstructure immediately below the degraded surface contained transformation products and an altered microstructure confirming exposure to elevated frictional heating. It is apparent that frictional rubbing during service operation was sufficient to heat the suction cover resulting in the observed "heat check" damage shown in Figure 2. During the pump operational cycles, alternate heating and cooling must have occurred at some point, which resulted in localized surface thermal fatigue cracking.

Making impeller adjustments and maintaining proper clearances are necessary to avoid frictional rubbing and excessive heat damage at contact surfaces. Inadequate or improper tightening of bolts after making any adjustments must be avoided. Verification of correct bolt torque and impeller clearance adjustments can not be over-emphasized to avoid severe damage from thermal stress and contact wear. ■

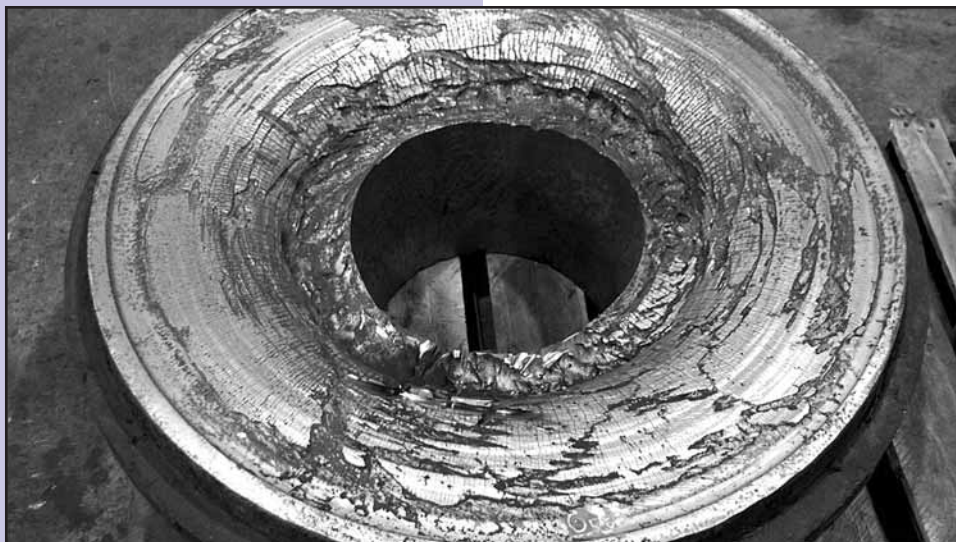
The condition of the returned, badly worn and extensively cracked cover is shown in Figure 1.

Evidence of severe abrasive and dynamic erosive wear as well as thermal fatigue cracking or "heat checking" can be clearly seen in the damage features. Symptoms of thermal fatigue by excessive friction heating are indicated by the characteristic cross hair line "heat checks" or "craze cracking" surface features shown in Figure 2. The cause of cracking of this nature results from the presence of steep temperature gradients generated by frictional contact heating which produces strains in the surface, which is

Figure 1. Condition of the severely damaged suction cover
