## ProSmart Prevents Thrust Bearing Failure Model 3600

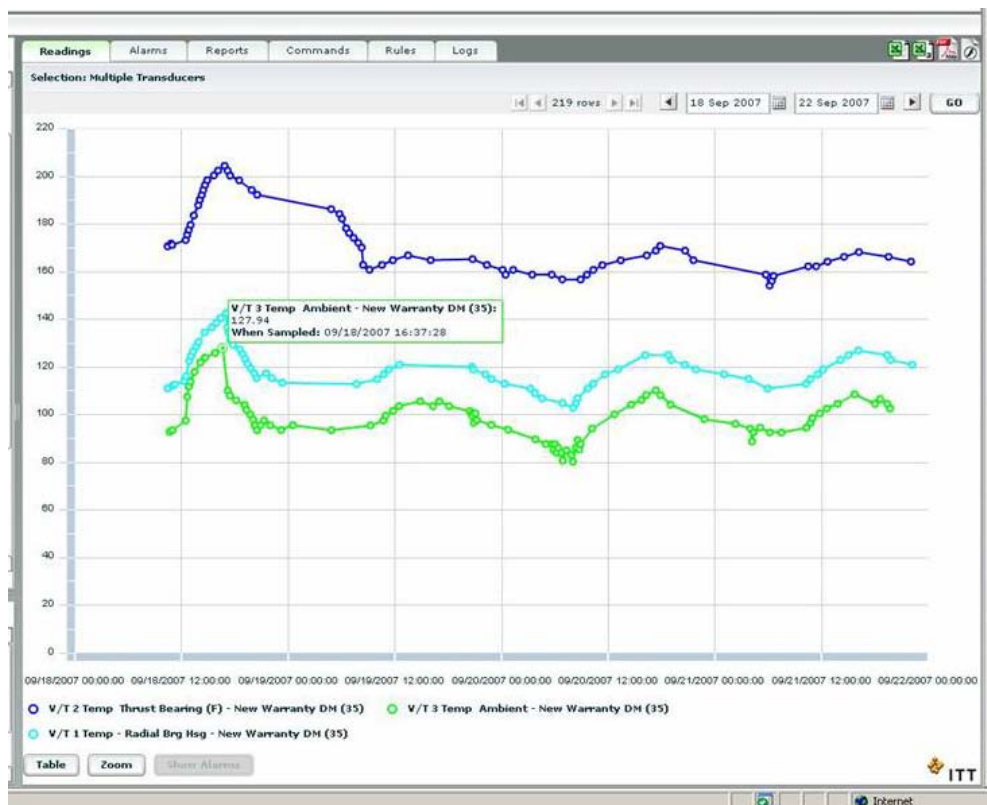
Hours after the unit was installed an alarm was received showing thrust bearing temperatures rapidly approaching 210°F and ambient temperatures within the pump house of 127°F. A call was made to the plant operators who reported that during a shift change several hours earlier, the pump house door was closed. Review of the trended ProSmart data shown below establishes a direct correlation of ambient temperature and bearing temperatures. This data was provided to our customer with a report of our findings. A vent in the pump house was installed to reduce the ambient temperature and the pump has been operating trouble free ever since.
